FATIGUE STRENGTH OF METAL SANDWICH

TYPE CONSTRUCTION.

William E. Lamb, Lt. Comdr., U.S. Navy

In Partial Fulfillment of the Requirements
For the Degree of
Aeronautical Engineer

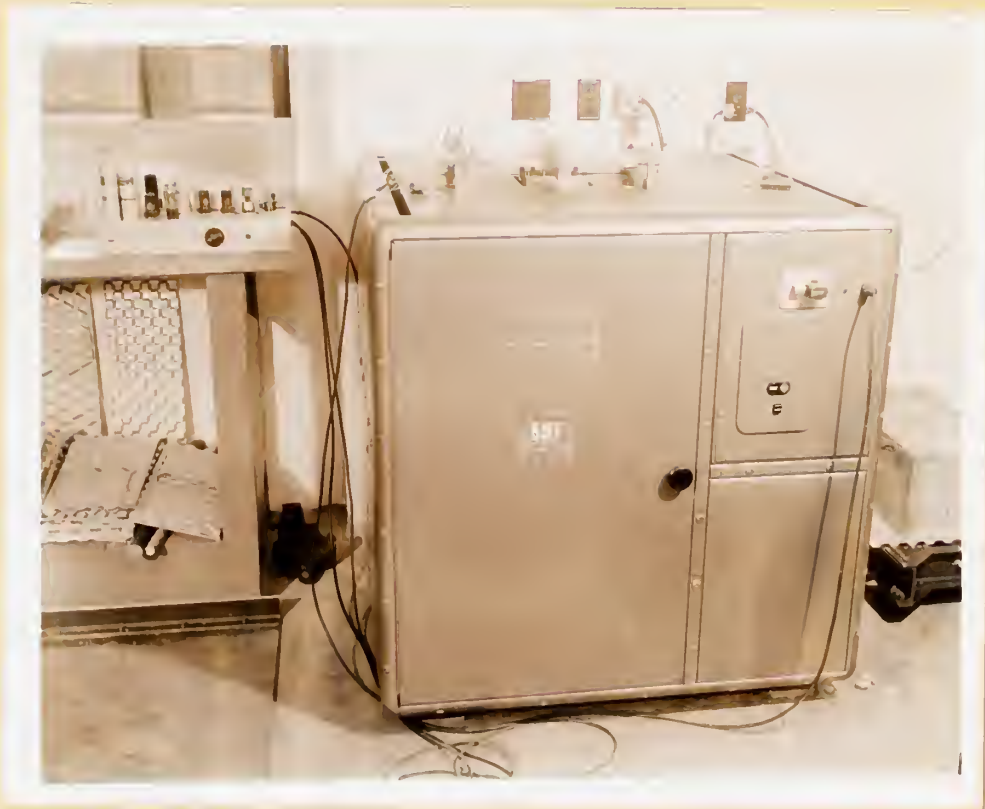
Figure 2

Testing Machine with Electronic Cut-off Circuit

The testing machine used was of the constant maximum load type. Its designation was Universal Fatigue Testing Machine SF-1-U. This machine obtained its load by means of an eccentric rotating mass that was constrained from moving in the horizontal direction. Rotation speed was constant at 1800 R.P.M., thus specimen was subjected to a sinusoidally varying load of constant maximum magnitude throughout the test. The machine was modified by having placed in series with the starting button, a two way switch. When this switch was open the machine could not be started. In parallel with this switch was a relay, which itself was part of the electronic control circuit. Thus when the relay was closed the starting circuit of the testing machine motor was closed and machine could be started by pressing the starting button. However, when the relay opened, the starting circuit was broken and the machine stopped. For testing with electronic control, the two way switch was left open and starting circuit completed through the relay. See Figure 4.

steel rods, that were secured to the stationary part of the testing machine. The specimen's end was squeezed between two of these rods to prevent up or down motion, but to allow some motion along its length. Details of the loading adapter and testing machine set-up may be viewed in Figures 2, 3, and 10.

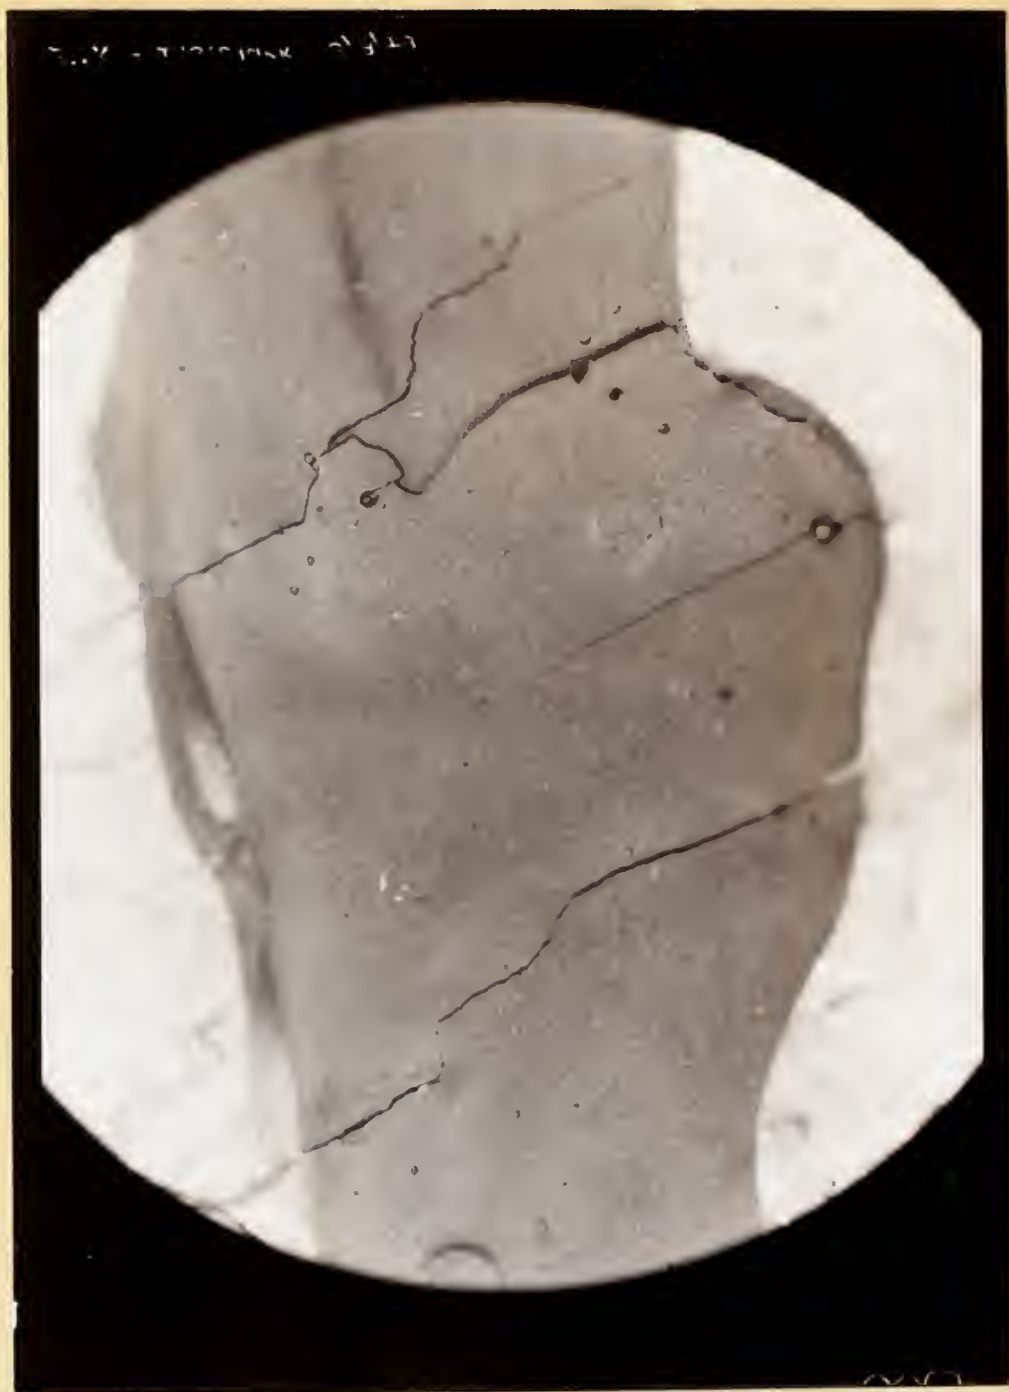
Figure 3

Photomicrograph of Crack Across Filament - Magnification 50 x

Figures 8 and 9 indicate the effectiveness of the crack detection. Figure 8 shows a crack across a saddle point with the graphite fracture ensuing. Figure 9 shows one of these cracks with the graphite and

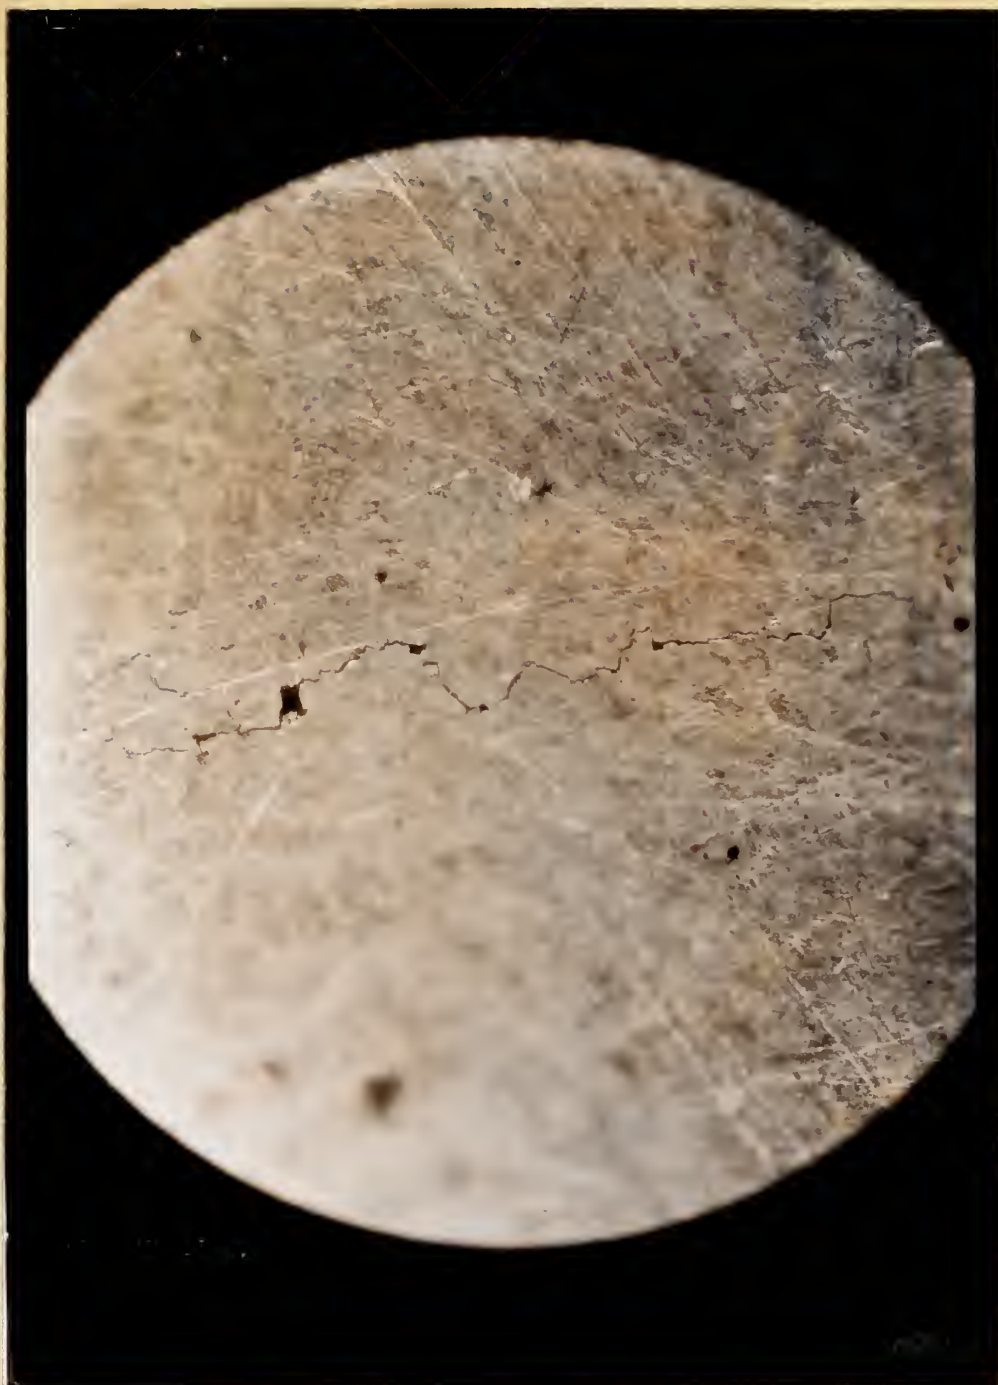
Figure 9

Photomicrograph of Crack with Filament and Cement Removed

Magnification 50 x

cerment removed. Many machine stoppages occurred with the crack causing the shut-down so fine as to be barely visible at a magnification of 40 times. It was necessary in almost all cases to utilize a resistance meter to determine in which saddle the crack occurred before the failure could be found.

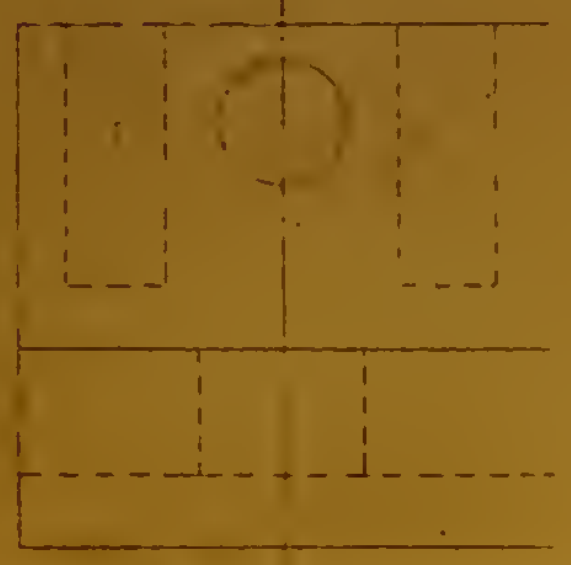
DRILL FOR 1/8" COTTER PINS

The load was applied to the specimens by means of two loading bars. One bar, on the bottom of the specimen applied the up load, the other on the top of the specimen applied the down load. These bars were one inch square steel, twelve and one-fourth inches long. To prevent local buckling failure of the specimens from the sharp edges of the bars, koroseal sheet one-eighth inch thick was placed between the bars and the specimen. End supports for the specimens were one-half inch diameter
